memorandum

dateSeptember 27, 2016toMr. Ells Freeman, Superintendent of Public Works, City of Hermosa BeachfromMargarita Jerabek, Associate Principal, Director of Historic Resources; Amanda Kainer, M.S., Senior
Architectural Historian, ESA PCRsubjectExterior Paint Analysis for the Community Center (Pier Avenue School)

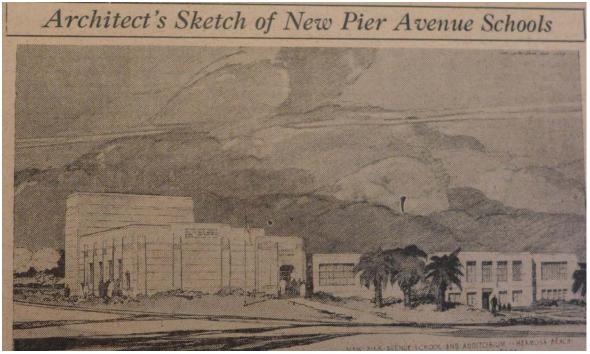
"Architect's Sketch of New Pier Avenue Schools," Hermosa Beach Review (March 28, 1935): 1.

the 1930s, the architect's rendering of the building was published in a March 28, 1935 issue of the *Hermosa Beach Review*. This black and white rendering depicts the building as painted in one, light color artculated with recessed bands encircling the elevations. The article describes the exterior as, "The exterior walls of the entire group of buildings will be of reinforced concrete treated with horizontal bands in a simple, modern and straightforward manner, with ornamental features only at the entrances and touches of scraffito¹ color decoration at important points on the Auditorium."² Due to the building's WPA Moderne style, the original design intent was for natural light to "enliven" the architecture, making the building "live" as the light changed throughout the day and in different weather conditions. This is a Neoclassical Revival/Beaux-Arts design concept that was incorporated into the WPA Moderne style. As such, a light, classical paint color would have covered the building letting light play on the elevations to create shadows and dramatic effects.

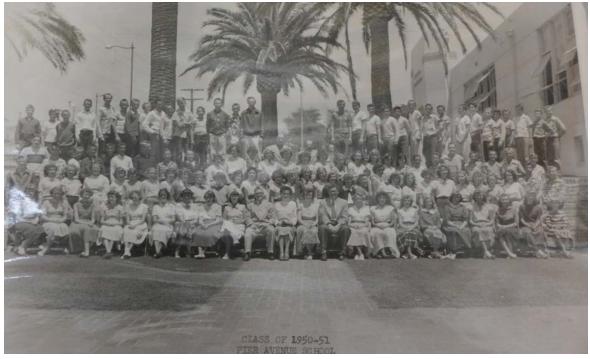
1950-51 (Hermosa Beach Historical Society)

The earliest known photograph of the Community Center (Pier Avenue School) uncovered by ESA PCR is dated 1950-1951. Taken 15 years after the 1935 rendering, this black and white photograph still shows the building was painted one light color with decorative stenciling adorning the upper aduitorium elevations. Other historic photgraphs identified also illustrate the building was painted in one color. Historic photgraphs from the 1970s show the building was painted in a warm peach color.

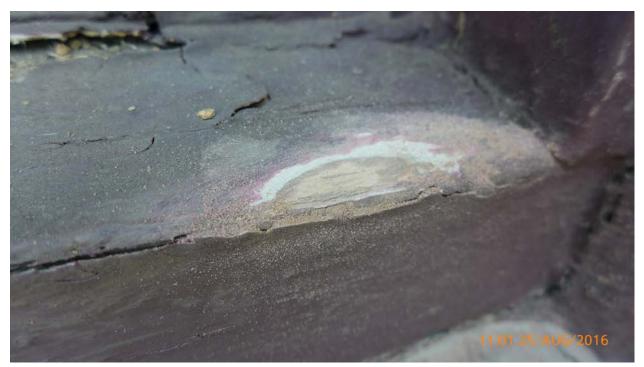
Window frame on west elevation of

Paint analysis was also conducted on the window frames. The stratigraphy window frames identify at least four layers of paint (listed with more recent first): dark grape purple, primer, purple grey, primer, grey, primer, warm peach, and brown.

Therefore, we recommend the following Benjamin Moore colors for the window frames: New Chestnut AC-6 or Richmond Gold HC-41.

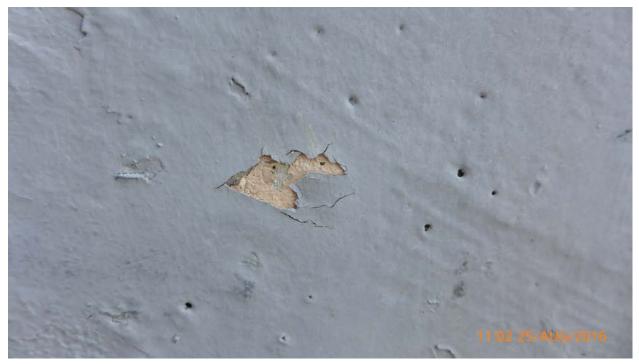
West elevation

It appears the concrete exterior has been painted a variety of colors over the years. Based upon paint stratigraphy there are at least four layers of paint (listed with more recent first): purple grey, grey, warm peach, and warm white. The closest match to the warm peach is Benjamin Moore Jumel Peachtree HC-54 and Crisp Straw 2157-50. Based upon ESA PCR's experience with the paint analysis of other WPA Moderne style buildings,³ we recommend the following Benjamin Moore colors: Fine China 2156-70, Ivory Tower 2157-70, White Blush OC-86, or Marble White OC-34.

In conclusion, ESA PCR recommends the following Benjamin Moore paint colors for the concrete exterior: Fine China 2156-70, Ivory Tower 2157-70, White Blush OC-86, or Marble White OC-34. And the following Benjamin Moore paint colors for the wood window frames: New Chestnut AC-6 or Richmond Gold HC-41. The stenciling on the upper elevations of the auditorium should be retained. Before the paint colors are selected from the paint samples, ESA PCR recommends doing mock ups of the colors on the exterior of building to view the paint in natural light and shade.
