70 IOTH STREET HISTORIC RESOURCE TECHNIAL REPORT

HERMOSA BEACH, CALIFORNIA
[16098]
Prepared for
CITY OF HERMOSA BEACH

Page & Turnbull

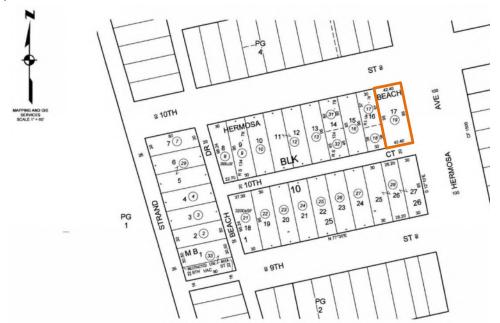
Figure 1. 70 10th Street, outlined in orange. Source: Los Angeles County Assessor, edited by Page & Turnbull, 2016.

This Historic Resource Evaluation has been prepared at the request of the City of Hermosa Beach (City) for 70 10th Street (APN 4187-010-017) in Hermosa Beach, California (Figure 1). The property owner, B&J Capital Group Investments, is proposing to retain the Craftsman-style single-family bungalow at 70 10th Street and constructing a new, three-story commercial building at the rear of the C-2 zoned lot. The bungalow was identified in the City's 2014 windshield survey as part of a grouping of beach cottages that is a potential historic district. Because the proposed project requires a discretionary permit and may impact a potential historic resource, the City requires a historic assessment for the purpose of the California Environmental Quality Act (CEQA) review.

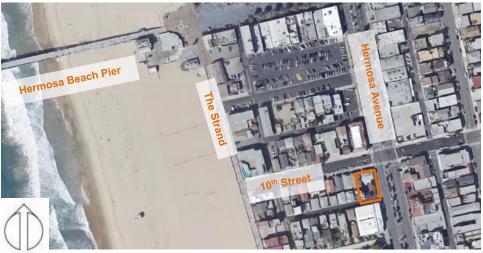
Figure 2. Outlined in orange is 70 10th Street. Source: Google Earth, 2016. Edited by Page & Turnbull.

70 10th Street is located in downtown Hermosa Beach at the southwest corner of 10th Street and Hermosa Avenue (**Figure 2**). It is one block west of the Pacific Ocean and The Strand, the concrete pedestrian and bike path that runs along the beach. Pier Avenue, a main east-west thoroughfare in the City that terminates in the Hermosa Beach Pier, is two blocks north of the property. Hermosa Avenue is a main commercial street in the downtown with mostly one- and two-story retail buildings between 8th Street and 15th Street.

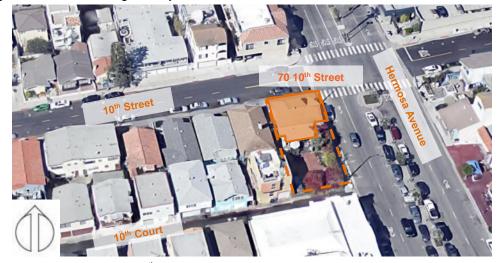
Figure 3. Aerial image of 70 10th Street with the main residence shaded and the lot in dashed outline. Source: Google Map, 2016, edited by Page & Turnbull.

The subject property is a corner parcel on the south side of 10th Street and west side of Hermosa Avenue with an alley called 10th Court at the rear (south) of the property; the main building faces 10th Street. The lot is 42.4 feet wide on 10th Street and 95 feet long on Hermosa Avenue, and is wider than the typical 30-foot wide lots on the block. As of the site visit, the main house is the only building on the lot, which is generally flat.

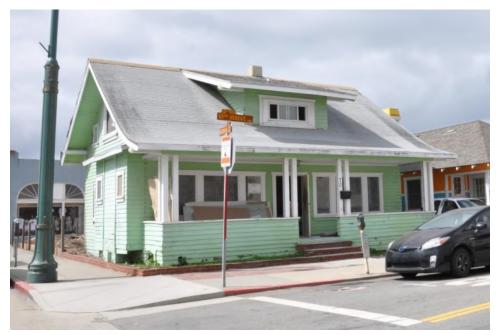
Figure 4. The front (north) façade of 70 10th Street, looking southeast.

The building at 70 10th Street is a one and a half story, Craftsman-style bungalow with a side gable roof that flares up at the north end (**Figure 4**). It is wood framed and set on a raised foundation. The building has an irregular plan with projecting sections at the east and rear (south) façades. A porch runs along the north (front) façade. The roof has exposed rafters but the rafter tail ends are concealed behind fascia boards. The roof is clad in composite shingles at the north side while the south side was undergoing re-roofing at the time of the site visit. A dormer is on the roof's north side.

The building is clad with horizontal clapboard siding, except at the projecting section of the rear façade. The windows are a mix of fixed and operable sashes and of varying materials. They typically have decorative wood surrounds with angled corners at the top.

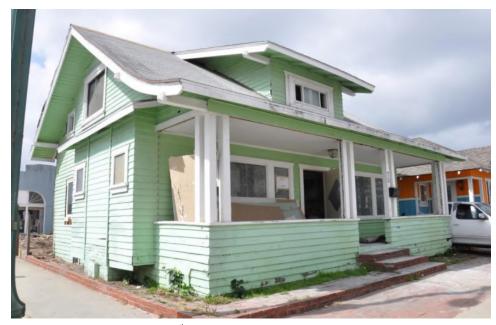
Figure 5. Front (north) façade of 70 10th Street with the flared eave and decorative ends to exposed roof beams. View looking southwest.

The primary (north) façade of 70 10th Street faces north onto 10th Street. The symmetical façade is set behind a porch that runs along most of the façade (**Figure 5**). The front door is centered on the façade and accessed by three brick steps and a concrete path bisecting the small brick-paved front yard; a metal plate covers part of the solid door. Flanking the door are tripartiate windows with non-original fixed wood-framed glazing (**Figure 6**).

A shed dormer is centered in the roof on the front façade. It is also clad in clapboard siding and has exposed roof beams at the east and west sides with the decorative flat-top pyramid ends. A replacement double sliding vinyl window is in the dormer with the typical wood window surruound with angled top corners.

The main house's roof extends over the porch and flares upwards. Roof beams extend at the east and west side of the porch and also have the decorative pyramid ends. The porch is clad with wood clapboard siding to the ground. Clapboard siding is also on the interior face of the low porch walls, which are topped with a wood cap. Paired wood posts support the roof and frame the opening from the steps to the porch; the corner supports have a third post. The posts and wood cap show evidence of screens that enclosed the porch until recently. The porch ceiling is finished wood board as is the flooring (**Figure 7**). A non-original light fixture is in the porch ceiling.

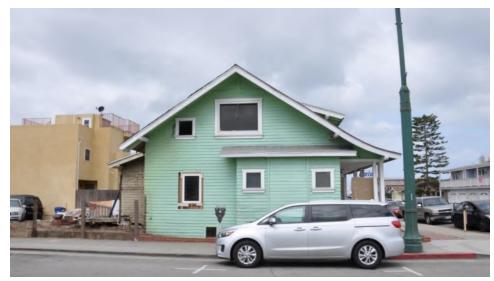
Figure 8: East façade of 70 10th Street along Hermosa Avenue. View facing west.

chimney that once extended through the house's roof. Above the brick, the center portion of the projecting bay is framed by wood trim and clad in wood siding. On each side of the center portion is a square window opening with fixed glazing that has plywood infill on the interior. To the south of the projecting bay on the first floor is a rectangular, vinyl window that was being installed at the time of the site visit.

All of the windows at the east façade have the decorative window surrounds, with the exception of the vinyl window replacement. A vent is at the foundation, just south of the projecting bay; a vent with wood lattice and the decorative window surrounds is at the porch's foundation. Brick pavers and edging wrap around from the front steps along the east property line.

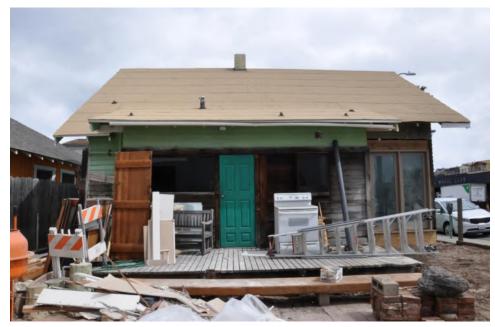
Figure 11: South (rear) façade with projecting section at the middle. View facing north.

The south façade is the rear of the building and faces the rear yard (**Figure 11**). The façade is asymmetrical and divided into three sections. The left (west) section has no openings but has surface-mounted utilities such as a water heater, electrical breaker box, and meters (**Figure 12**). The center section projects into the rear yard and has an attached wood deck. It has a shed roof that extends from the main roof; both were in the process of re-roofing at the time of the site visit and were not clad. Wood clapboard siding is on the east and west ends of the central section, as well as below the shed roof, but the east façade mostly has a non-original wood board siding. A wood-paneled door is centered in this section flanked by a wide, fixed, picture window on the west side and a projecting box window with fixed glazing on the east side.

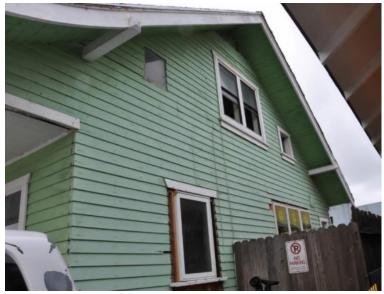
Figure 15: West façade with the tripartite replacement window. View facing northeast.

The west façade is asymmetrical and faces a narrow side yard that is enclosed by a wood fence and gate (**Figure 14**). The two of the first-floor windows were being replaced with new windows at the time of the site visit; both had sections of their decorative window surrounds removed. The window toward the north (front) end is a smaller window while the one toward the center of the building is wider and has a tripartite replacement window. The south end of the first floor has a square fixed window with frosted glazing that corresponds to a shower stall in the rear projecting section; the square window has its original decorative surround (**Figure 15**).

On the second floor are two square windows flanking a central window opening. The central windows are two non-original aluminum double-hung windows. The square window to the west appears to be an original wood-framed casement window but has no window surround. The square window to the east has its decorative window surround and is a fixed window. A wood lattice vent is at the gable apex. Two beams with decorative ends extend as roof supports. The clapboard siding at the south end has lost some boards and the raised foundation is visible.

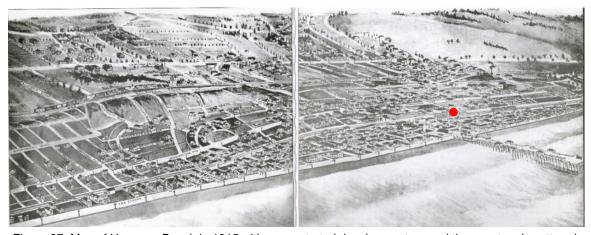
Figure 27: Map of Hermosa Beach in 1915 with concentrated development neared the coast and scattered elsewhere. 70 10th Street is marked with the red dot. Source: Hermosa Beach Historical Society in *Images of America: Hermosa Beach*.

Greater growth would come with the arrival of the Pacific Electric rail line. By 1910, Hermosa Beach was a stop on the Pacific Electric's "Balloon Route Excursion" that ran along Hermosa Avenue. The train brought more tourists and potential new residents to the beach community. The Berth family built the first hotel at 10th Street and the Strand in 1907. The new city spent thousands of dollars on street and lighting improvements to attract new residents. Much of the early residences were summer homes for those in Los Angeles and Pasadena. Most of the housing stock was the vernacular beach cottage or bungalow that could be built for a modest amount. Development was denser near the coast and toward the southern end of the city, though even in the 1920s, many blocks had several undeveloped lots. In the hills inland, Greek and Japanese farmers grew carnations, chrysanthemums, and other flowers (**Figure 27**). 13

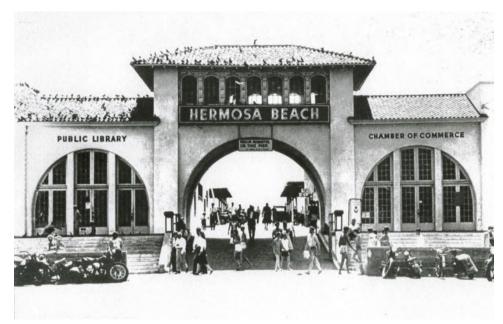
Figure 28: Mission Revival-style building at entrance to the Hermosa Beach Pier, seen in the 1940s. It was demolished in the 1960s. Source: Hermosa Beach Historical Society in *Images of America: Hermosa Beach*.

archway that had an upper level viewing deck (**Figure 28**).¹⁴ In 1917, the Hermosa Beach Bathhouse Company announced plans for a bathhouse at The Strand just south of the pier. The Spanish Colonial Revival-style building provided a private place for beach visitors to change and store their belongings.

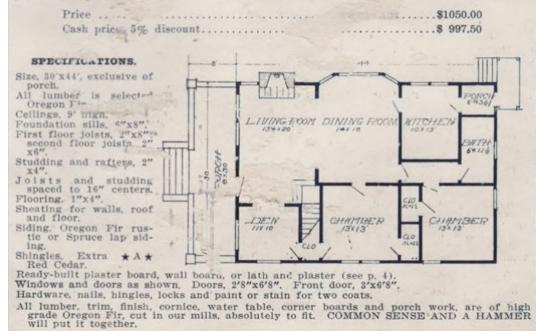
A house covering a good deal of ground, and having attractive long, sloping lines.

Exposed rafter-ends, overhanging roof and well-balanced brackets help in the attractiveness of the scheme. The second floor affords opportunity for three extra rooms, if you wish to put them in.

Figure 29: Example of a pattern book plan available from Ready Built House Company of Portland, Oregon, 1915. Source: Bungalow Home Style, http://www.bungalowhomestyle.com/plans/ready-built-fenner-123.htm.

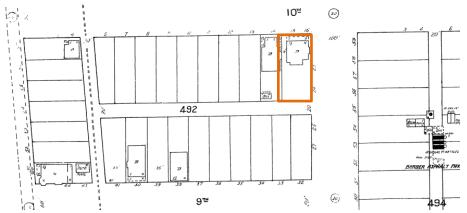
Figure 32: The 1912 Sanborn Map showing 70 10th Street with the same footprint as today. Source: Redondo Beach Sanborn Map, edited by Page & Turnbull.

According to historic Los Angeles County Assessor map books, the first improvement on the property occurred around 1911. No building permit or architect has been found. The 1912 Sanborn Fire Insurance Map shows a one-and-a-half story dwelling with the same footprint as the current building, including a porch along the north (front) façade and a projecting section at the rear (south) (**Figure 32**). Only the house next door at 64 10th Street had been constructed on that side of the street by that time.

boom that saw the lots near the beach infill with new housing (**Figure 32** and **Figure 33**). Their small scale and simple architectural detailing is consistent with beach bungalows of the early 20th century and their proximity to the ocean reinforces their use as dwellings for those visiting the beach. The 2014 Survey found only one other grouping of beach bungalow housing in Hermosa Beach, suggesting that an intact row of early beach bungalows is rare in the City. The other grouping of bungalows dating from 1923 to 1930 is at 1101 through 1041 2nd Street, which is east of Pacific Coast Highway and about a mile from the ocean.

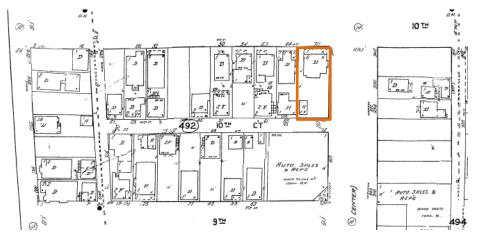
Figure 33: The 1927 Sanborn Map showing 70 10th Street had a garage at the southwest corner of the property. Source: Hermosa Beach Sanborn Map, edited by Page & Turnbull.

At some point, the garage seen in the 1927 Sanborn map was demolished; the building permit records noted that the property did not have a garage by 1969. A photograph from the 1976 realtor record shows that a screen had been added to the porch; it appears the entire porch was

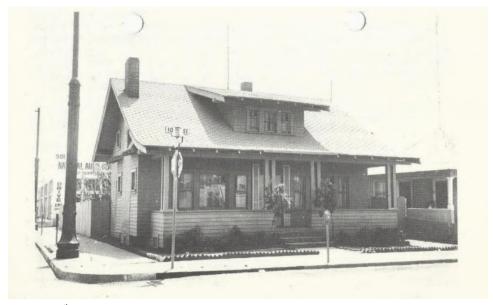
Figure 34: 70 10th Street in a 1965 South Bay Board of Realtors records photograph. Note the tripartite front windows and the chimney at the east façade. Source: Hermosa Beach Historical Society.

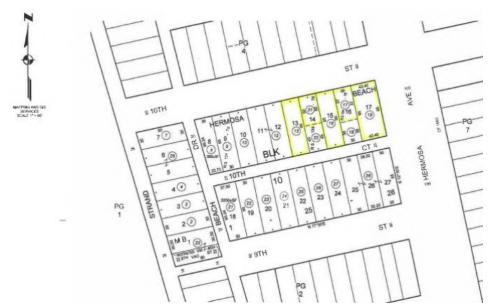
Figure 39: Map with the parcels within the potential historic district on 10th Street highlighted. Source: City of Hermosa Beach.

The 2014 Survey identified a potential historic district consisting of five beach cottages from 1914 to 1930 on 10th Street. The grouping of 50, 54, 58, 64, and 70 10th Street was "potentially eligible as distinctive examples of one-story beach bungalows in Hermosa Beach with good integrity." Based on the recent site visit and a review of the Los Angeles County Assessor map books, it appears the five consecutive lots on the south side of 10th Street date from 1907 to 1923 instead and have one and one-and-a-half story, single-family dwellings (**Figure 37** and **Figure 38**). Four of the five have a second building at the rear that were constructed later and some of which are on separate legal parcels that are not part of the potential district (**Figure 39**).

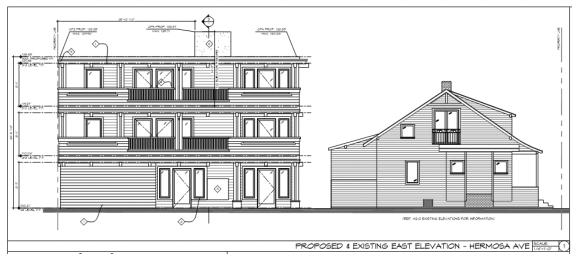
Figure 42: Proposed east façade of new building (left) and existing ca. 1911 bungalow. Source: A3.10, Peha & Associates Architecture, December 21, 2017.

The primary (east) façade faces east to Hermosa Avenue. The ground floor includes the main entrances to the elevator lobby and a retail space on north side of the building. The two entrances are similar with a center typical door flanked by sidelights. They are recessed under a slight overhang that is visually supported by two paired posts that frame the retail entrance. Between the two entrances is a mailbox. The south side of the ground floor is flush to the property line, clad with siding, and has no openings.

The upper two floors have covered walkways that line the east façade and wrap a portion of the south façade. The walkways provide access to the two offices on each floor. The walkway railings consist of a low wall clad in siding and five sets of equally spaced posts. The posts at the north end align with those on the ground floor, while the ones in the middle have wood picket railings instead of siding between the posts. In addition, decorative siding elements that appear as two horizontal bars are found elsewhere in the low wall.

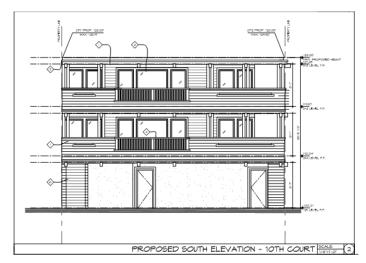
Figure 43: Proposed south façade of new building facing 10th Court alley. Source: A3.10, Peha & Associates Architecture, December 21, 2017.

inside the building is a stucco wall with two hollow metal doors; the right (east) door leads to the elevator lobby while the left (west) door leads to a mechanical room.

The second and third floors are divided into three sections each. At the east end is the covered walkway wrapping around the southeast corner. The building façade is set back here with two windows. The middle section is not setback, except at the off-centered, tripartite window that is slightly recessed. Below the window is wood picket railings instead of siding. At the west end, the façade is set back behind a planter box and has a pair of windows corresponding with the southwest stair. The top rail of the covered walkway, wood picket railing, and southwest corner recess appear to visually continue across the façade as a trim piece on the siding. The same decorative siding element on the east façade also occurs on the south façade at the east and west sides of the wood picket railing.

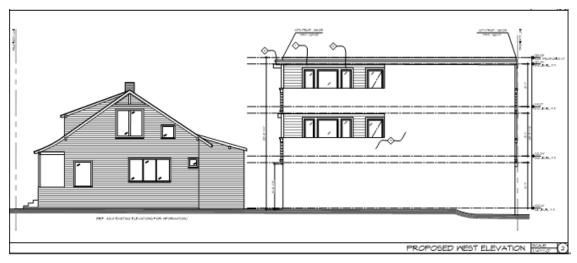
Figure 45: Proposed west (right) façade of new building with the west façade of the bungalow at left. Source: A3.11, Peha & Associates Architecture, December 21, 2017.

The west façade consists most of a masonry wall. At the northwest corner of the second and third floors is the recessed covered deck. The façade here has one set of tripartite windows and a single typical door providing access to the deck from the north office on each floor.

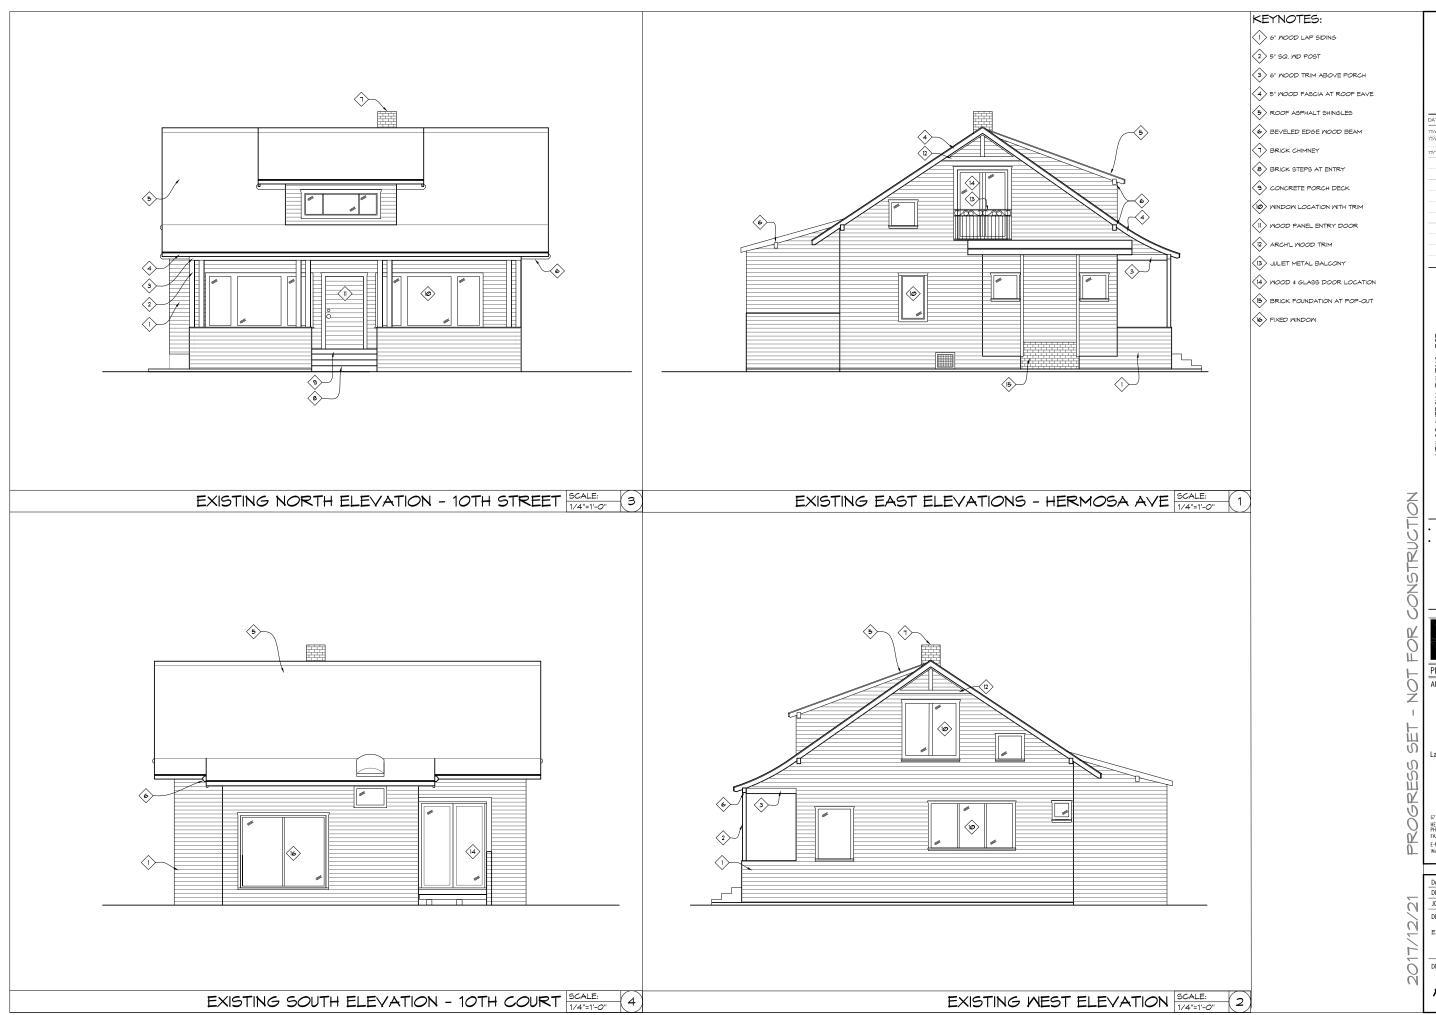
DRAWING NUMBER

EXISTING ELEVATIONS

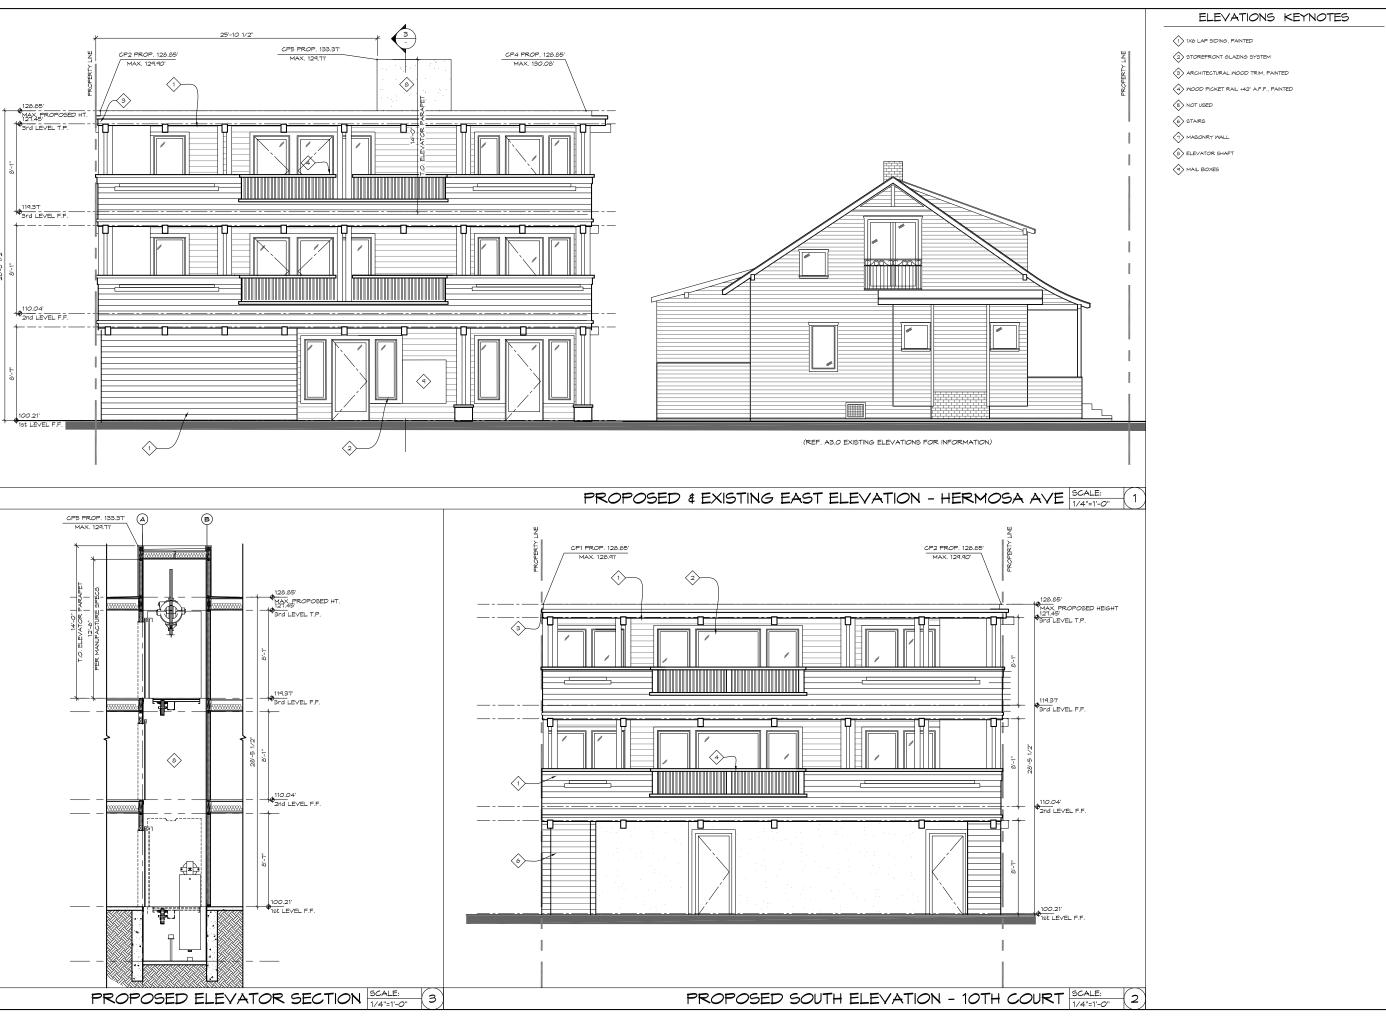
DRAWING NUMBER

PROPOSED ELEVATIONS
