Hermosa Beach Community Theatre Market and Building Assessment —

FOR THE CITY OF HERMOSA BEACH, CALIFORNIA

Field Date: March 9, 2020 Report Date: August 13, 2020

Hermosa Beach Community Theatre 710 Pier Ave. 90254 Hermosa Beach California

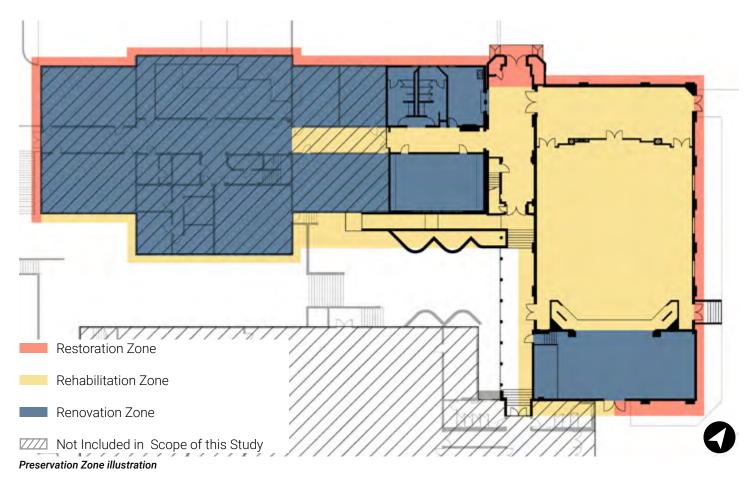
To provide facility compliance with the Rehabilitation Standards, the areas of the building have been divided into the following three categories based upon the architectural significance and physical condition to be used in conjunction with the Preservation Zone illustration, see below.

These areas are of special architectural significance and should be protected and restored as nearly as possible to their original form and condition. Restoration zones include the entire exterior of the original building.

These areas and elements are subordinate to the significant architectural details covered under Restoration Zones. However, the areas must be retained and restored during any and all alterations and repairs. Rehabilitation areas of the building include the interior of the theater, corridors, and interior courtyard spaces across the building.

These areas are of lower importance due to their location in the building. These spaces may be altered, provided the alterations have no negative impact on the significant elements outlined in the Restoration and Rehabilitation Zone descriptions. Spaces include the support spaces, restrooms, and a variety of teaching and flexible spaces.

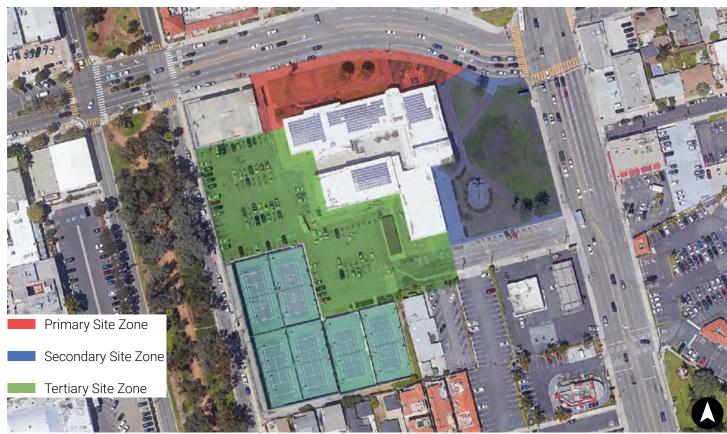
The area to the west and southwest of the building is effectively paved from the building line to the edge of the property for parking and tennis courts. Should an addition or added mechanical equipment be deemed necessary, from a purely preservation-driven perspective, this would be the location best suited for new work. That being said, the area's lack of adjacency to the theater or main entrances would present multiple logistical challenges for an addition.

Site planning zone illustration

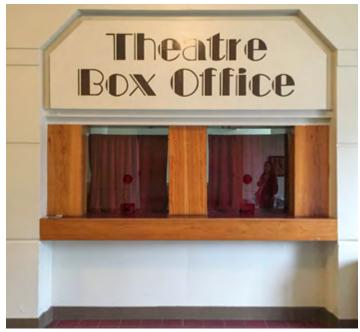
The box office ticket sales window located in the front lobby hall is not ADA accessible. The recommendation is to remove the current box office window system and replace it with a counter with two levels, one for standing patrons and one for guests in a wheelchair. The inside of the box office would need to maintain a clear access path to the electrical closet for maintenance staff.

Box office ticket sales window

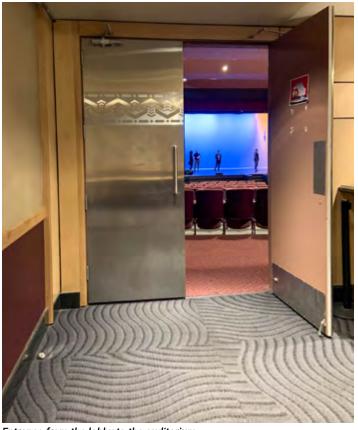
It was observed that paper signs have been taped to the doors and walls. These are not compliant with current codes.

Entrance from the lobby to the auditorium

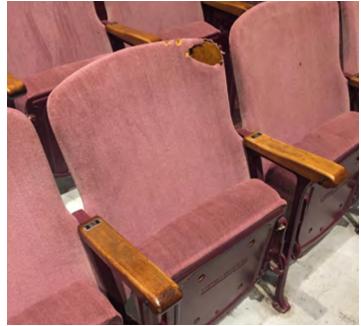
Worn upholstery on the historic seating

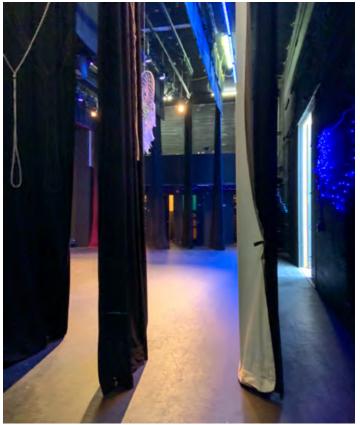
No acoustical panels on the stage walls

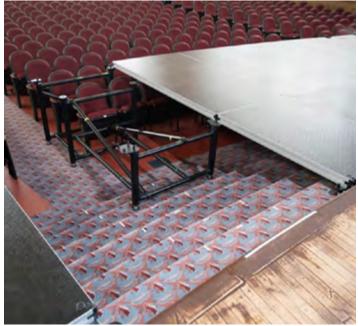
Stage Right - example of a stage extension, partially constructed

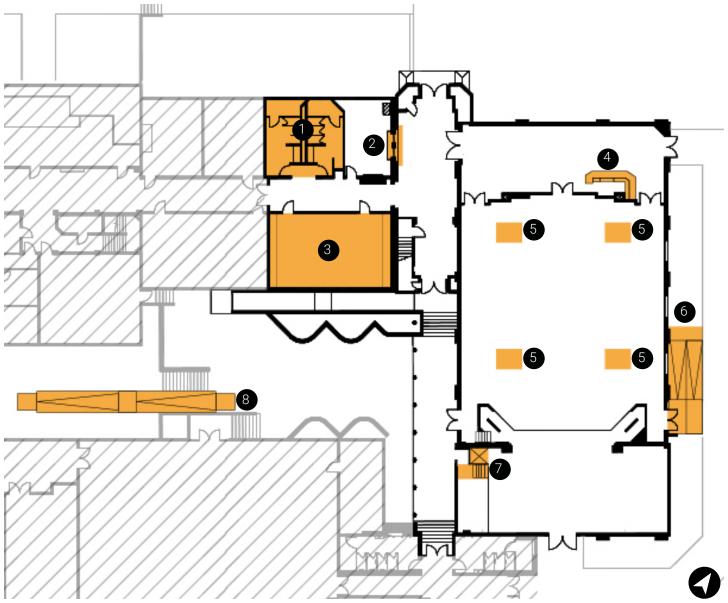
The following diagram depicts the locations within the existing building that require upgrades to serve the general public for compliance disabled accessibility. 1. Denotes the public restrooms off the main lobby hallway. These rooms would be required to be redesigned to accommodate proper spacing and maneuverability as well as proper mounting heights for all fixtures and equipment. 2., 3., 4. The box office integrated into the main lobby hallway, the dressing rooms, and the concessions stand in the main lobby all require revisions to their counter heights for proper unobstructed forward and side reach envelopes. Any projections within these areas should also maintain compliance with the code required depths. 5. Disabled seating positions within the assembly seating space should provide proper access and clearances. They should also provide equal distribution about the audience chamber and offer a designated

- 1 Accessibility upgrade at restrooms
- 2 Accessibility upgrade at box office
- 3 Accessibility upgrade at make-up stations
- 4 Accessibility upgrade at concessions
- 5 Accessibility upgrade at rear and front seating
- 6 New exterior ramp
- 7 New lift to stage
- 8 New exterior ramp

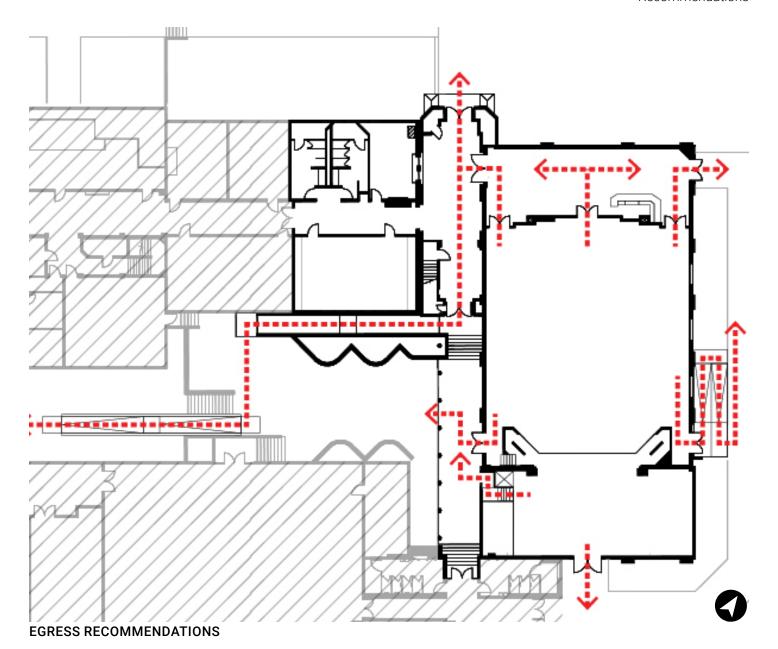
This diagram represents the egress routes for the audience chamber and the stage. Each of these spaces represent two distinct spaces where egress is required. The audience chamber depicts five (5) exits. Three (3) from the rear of the auditorium and two (2) from adjacent to the stage on both house left and house right. The identified locations do provide for an equal distribution within the room. The stage contains one (1) means of egress at stage left. A second means of exiting could be introduced into the stage rear loading door depending on the occupant loading.

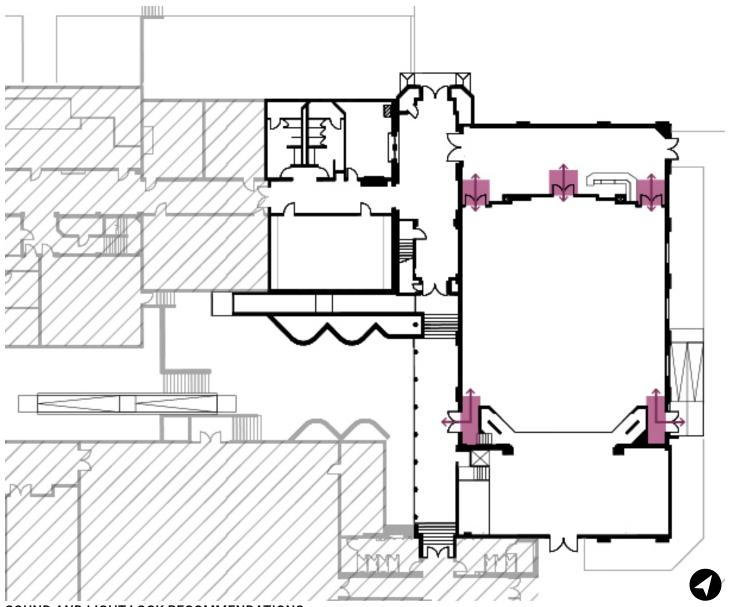
Circulation through proposed sound and light locks

This diagram represents the five (5) locations for the recommended sound and light locks. These should be located at each of the entry and exit points into the theater. These are to be designed so that no light leak or noises from the exterior or lobby disturbs the performance. It also prevents distractions from when a guest enters or leaves during a show. The spacing within the sound and light locks should comply with code and dimensional maneuvering distances.

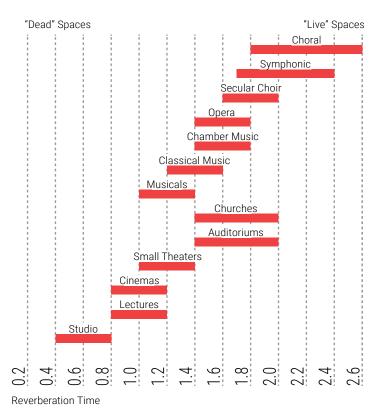
Preferred ranges of reverberation times at mid-frequency (average of 502 and 1000 Hz)
